Intel® Celeron™ Processor Specification Update

Release Date: December 1998

Order Number: 243748-009

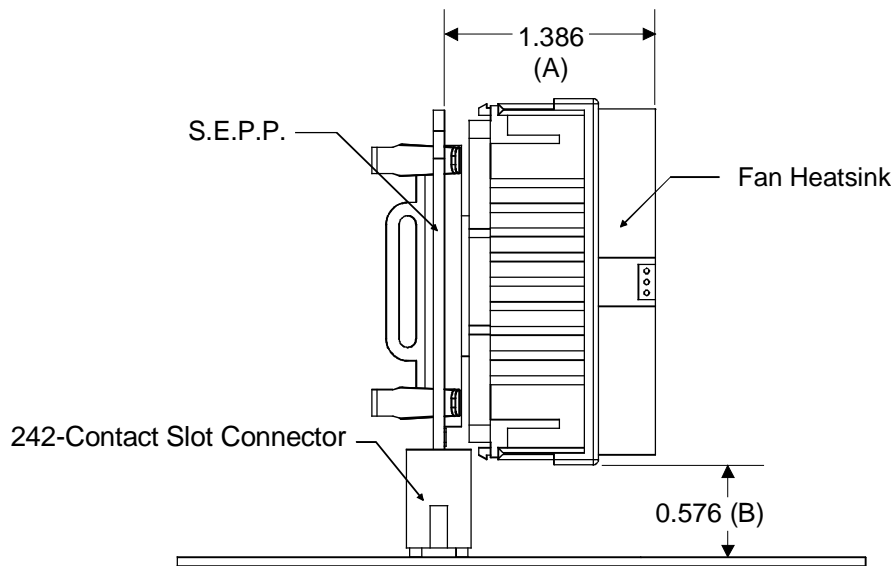
Figure 20. Side View Space Requirements for the Boxed Processor

Figures 20, 21, and 22, and Table 34 of Section 6.2 of the *Intel Celeron Processor at 266 MHz, 300 MHz, 300A MHz, and 333 MHz Datasheet* show incorrect fan heat sink dimensions for the boxed Intel Celeron processor. The correct figures and table are shown below.

The maximum depth of the fan heat sink to the processor substrate should be 1.386", not 1.291" max. The minimum height clearance above the baseboard should be 0.576", not 0.485". The fan shroud height should be 2.02" and 4.74", respectively, not 2.19" max. and 4.90" max. Figure 22 should show reference "G" for the minimum airflow keepout zone from the inlet of the fan heat sink, and reference "F" for the minimum airflow keepout zone from the ends of the fan heat sink.
